SHELBURNE FALLS FIRE DISTRICT
RESERVOIR DAM

MA 00462

PHASE I INSPECTION REPORT
NATIONAL DAM INSPECTION PROGRAM

APRIL 1981

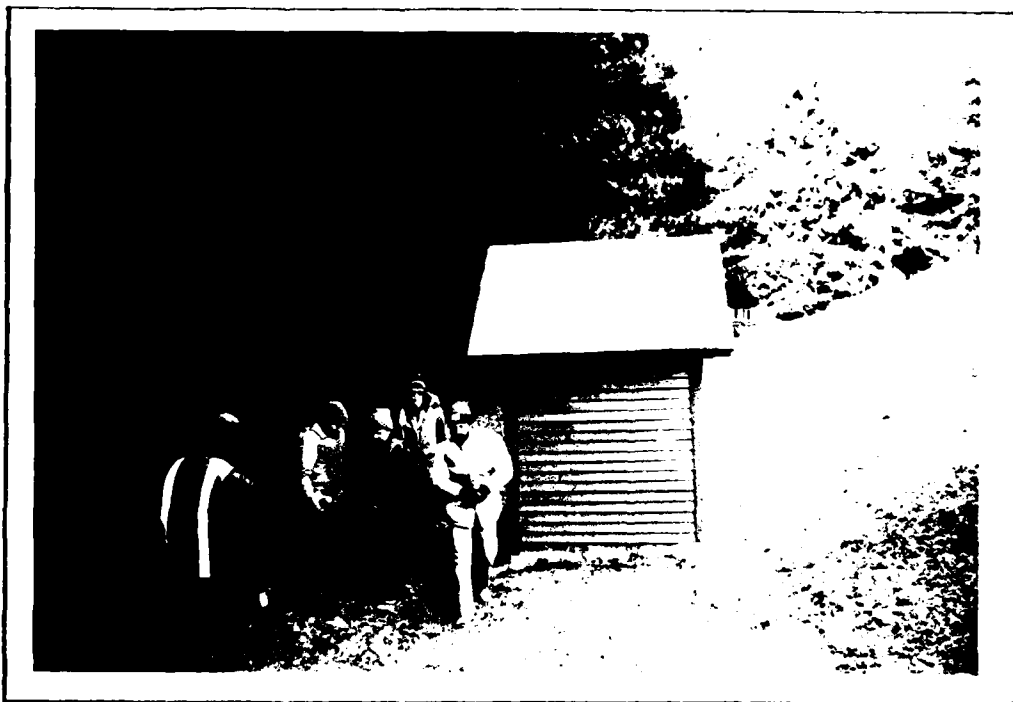
The dam appears to be in fair overall condition. The entire embankment has a well maintained grass cover. The closest trees to the downstream toe of the dam (photo no. 3, Appendix C) are 20 feet away from the toe of the embankment. Clear seepage (about 2 gpm) was noticed around the outlet of the two 8-inch diameter cast iron low level outlet pipes. The concrete spillway appears to be in good condition except for some minor spalling on the two, four foot high buttresses.

3. GATEHOUSE AT THE DOWNSTREAM TOE OF THE DAM. (12/3/80)

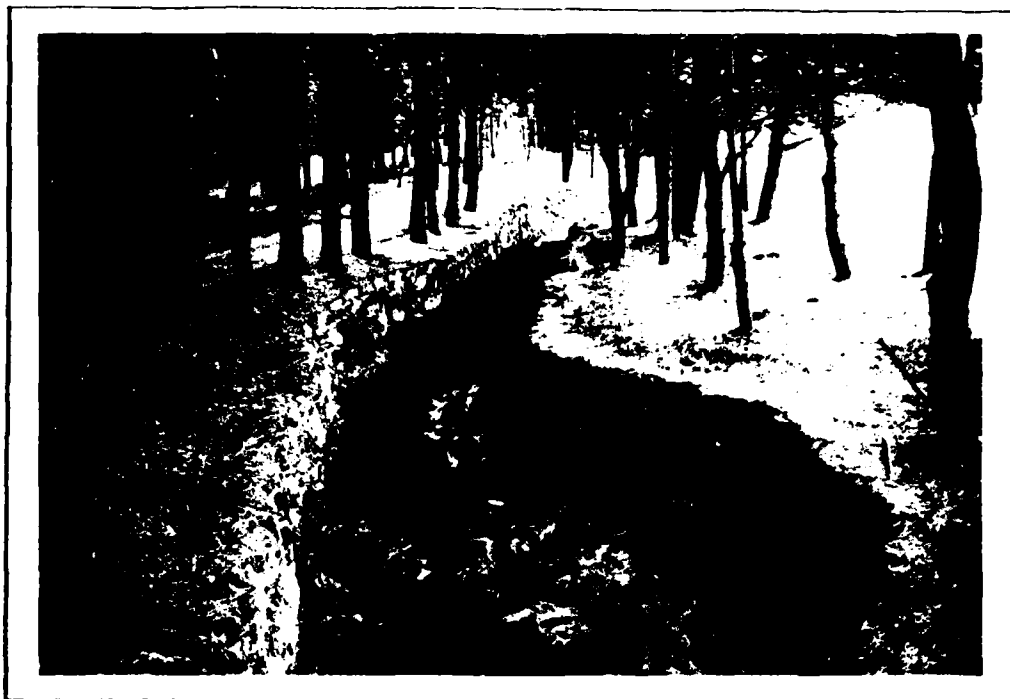
5. TYPICAL LINED CHANNEL DOWNSTREAM OF THE SPILLWAY OUTLET CHANNEL. (12/3/80)
